Manhole Inspection Summary

Manhole # S02AA2002MH

Insp Date: **8/3/06 7:05 AM**

Location Address: **3501 Bancroft Rd** Cross Street: **Park Heights Ave**

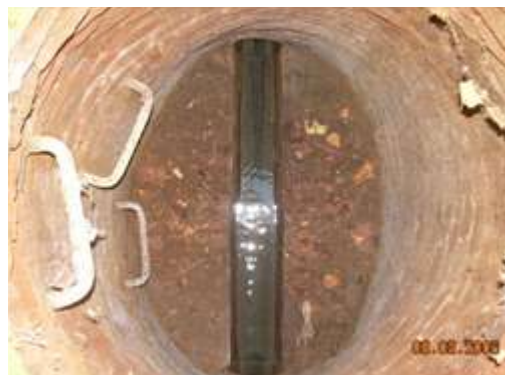
Top View

Bench ☒ Exists Material: **Brick** ☐ Parged ☐ Debris (not Condition related)
Condition: ☐ Sound ☐ Cracked ☐ Root Intrusion ☐ Deteriorated ☐ Leaks ☒ **Debris**

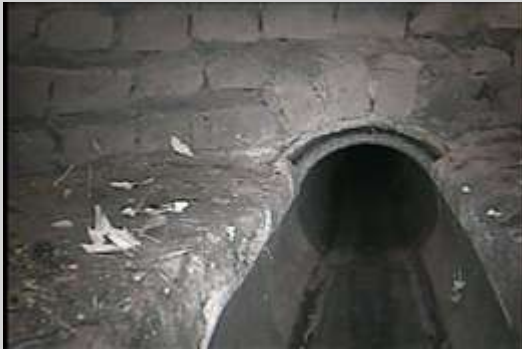
8 in. Circular Gravity Sewer Pipe Out @ 12 O'Clock

Invert Depth: **6.78** (ft.) Flow Characteristics: **Slow**

Deposits: ☒ None ☐ Mud ☐ Sludge ☐ Debris ☐ Grease

Infiltration: **None** Pipe Seal Cond: **Sound**

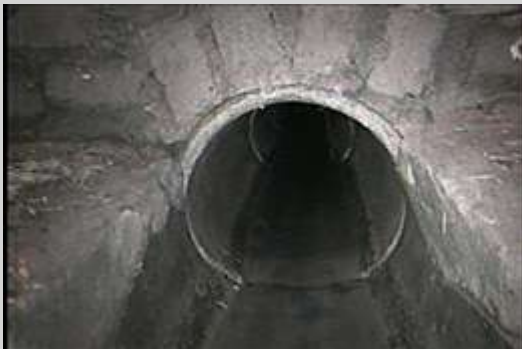
8 in. Circular Gravity Sewer Pipe In @ 6 O'Clock

Invert Depth: **6.69** (ft.) Flow Characteristics: **Slow**

Deposits: ☒ None ☐ Mud ☐ Sludge ☐ Debris ☐ Grease

Infiltration: **None** Pipe Seal Cond: **Sound**
